REPORT OF RESULTS: STORM CLAMPS™ FOR FASTENING OF WOOD PANEL WINDOW OPENING PROTECTION IN HURRICANE REGIONS

Materials Tested:
Storm Clamps

Report #: 4109-003_08052009

Date of Issue:
August 5, 2009

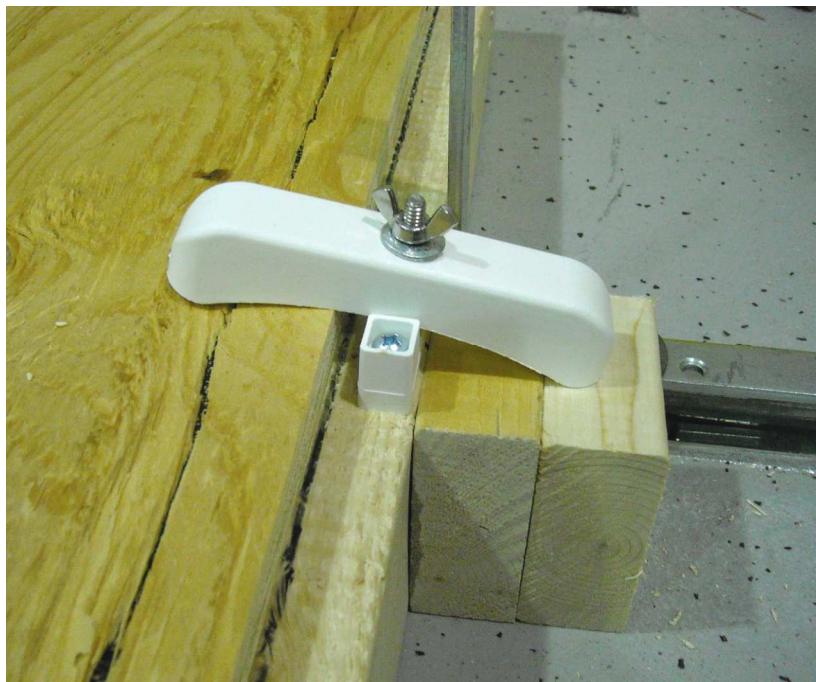
Figure 2: Installed Storm Clamp™

The Storm Clamp™ product consists of a mounting base which is screwed into the building structure adjacent to the window opening, a clamping arm, and a bolt/wing nut to attach the clamping arm to the base. The base and the clamping arm are made of an injection molded plastic. The Storm Clamp™ product is shown in Figures 1 and 2.

The clamps were fastened to the frame using 2-inch-long #12 pan head screws so that there was a 1½" penetration into the frame. The clamps were installed vertically on the sides of the frame. The clamps were positioned 17" from the top and bottom of the plywood sheet respectively for a total of 4 clamps. Figure 2 shows the clamps installed on the frame. For all tests, the white clamps were used. Extensions to the sides of the frame were added at the clamp locations to simulate additional building structure.

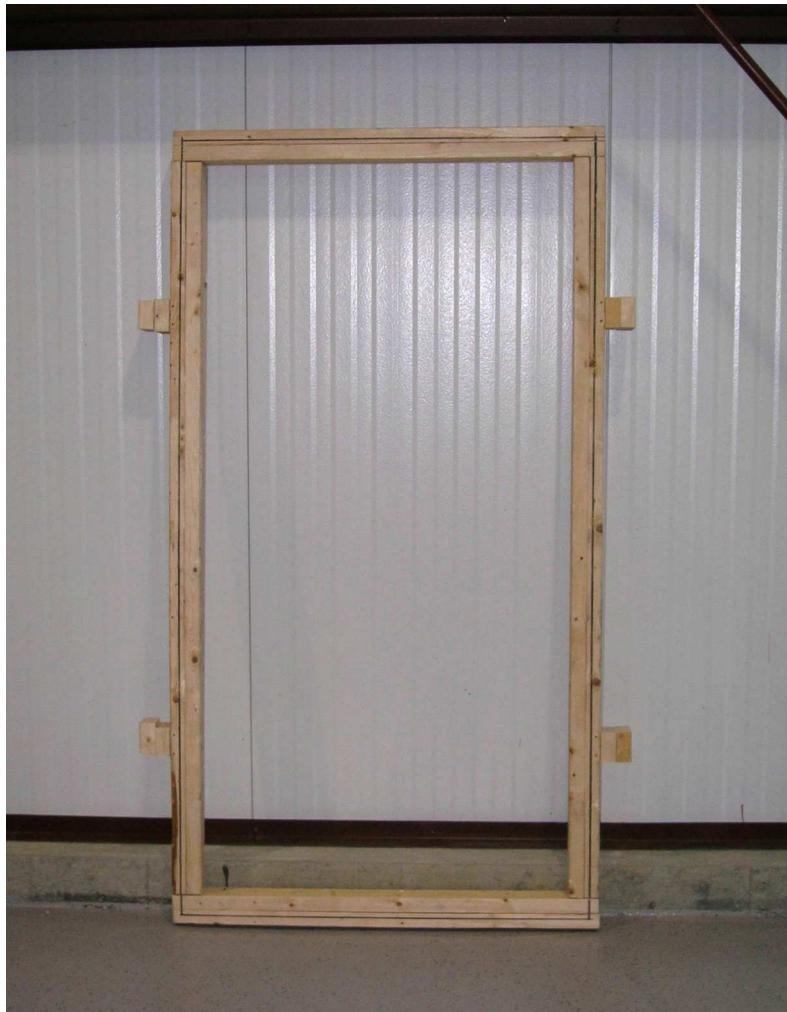
Figure 3: Window frame used for testing
(Black lines indicate the area to be covered by plywood)

In order to simulate a window opening, a wooden frame with an opening size of 3' x 6' was constructed out of 2x4 lumbers as shown in Figure 3.

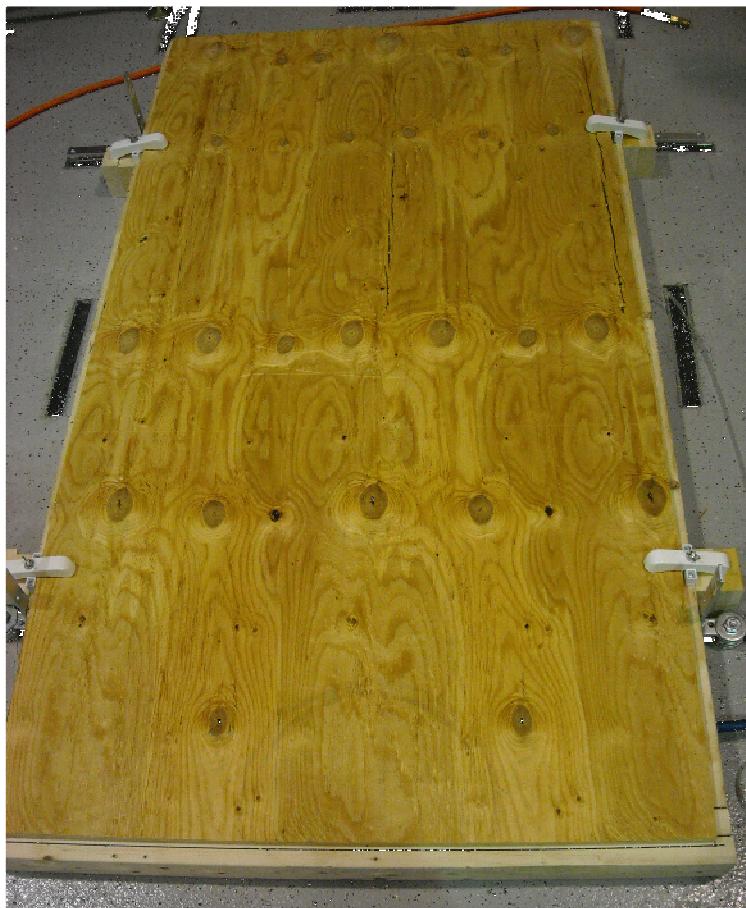
Figure 4: Frame with clamps fastened and plywood secured.

The plywood was placed over the opening and the clamps were tightened so that the plywood was flat against the frame.

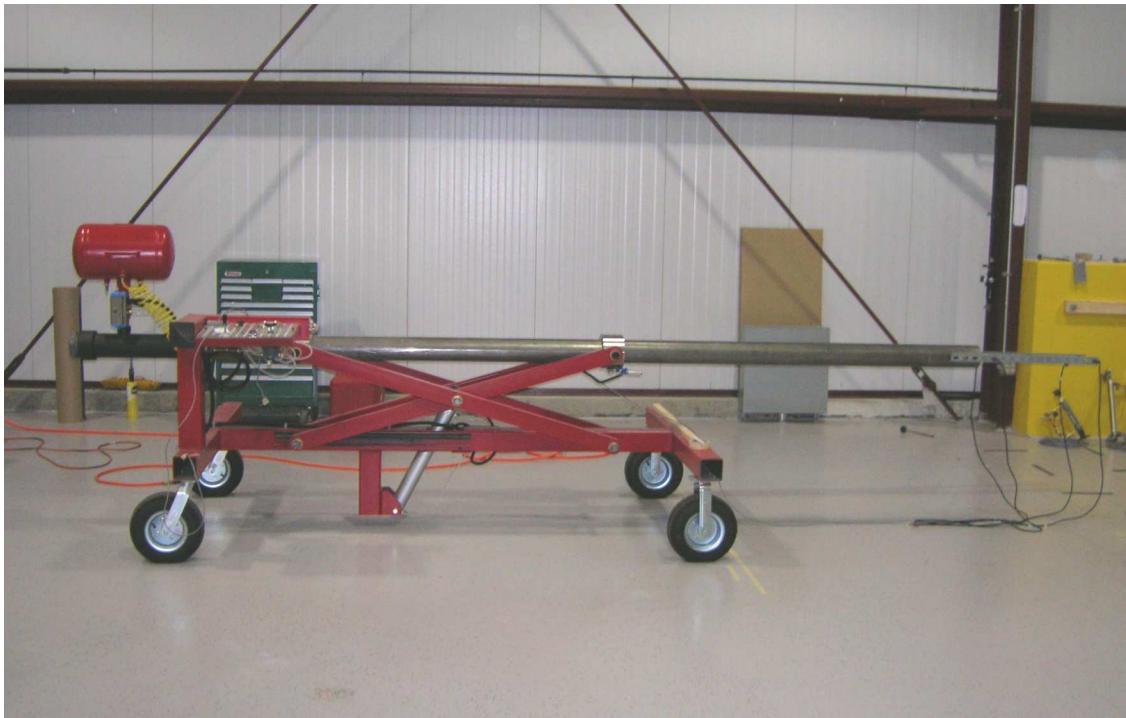
Figure 5: Air cannon apparatus used for launching large missile

The test protocol calls for impacting the plywood panel with a large missile at 50ft/sec using Douglas Fir 2x4 weighing 4100 ± 100 grams and having a length of 7' 9". An air cannon was used to propel the missile using compressed air. The air cannon apparatus is shown in Figure 5.

A pair of light sensors was used to time the missile as it left the air cannon. The velocity of the missile was calculated based on the distance between the sensors and the elapsed time. The speed measuring system was verified per ASTM E1886 Section 9.1.3. After impact the clamps were examined to confirm that they had not detached. The size of the missile penetration was examined to make sure a 3" diameter sphere would not be able to pass through the hole. Each test specimen is impacted once and then subjected to the cyclic pressure testing. The first specimen was impacted within a 2½" radius circle with the center of the circle being 6" from the

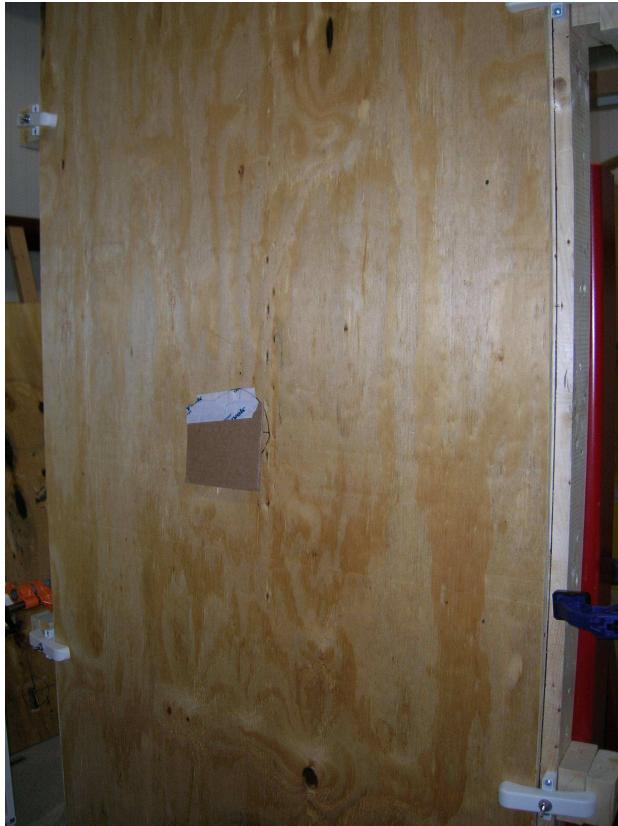
Figure 6: Cardboard used to cover hole after impact.

bottom and from the left of the plywood sheet. The second specimen was impacted within a 2½" circle in the center of the plywood sheet. The third specimen was impacted within a 2½" radius circle with the center of the circle being 6" from the top and from the right of the plywood sheet. After each impact the hole was covered with a small piece of cardboard to prevent splinters from piercing the air bag.

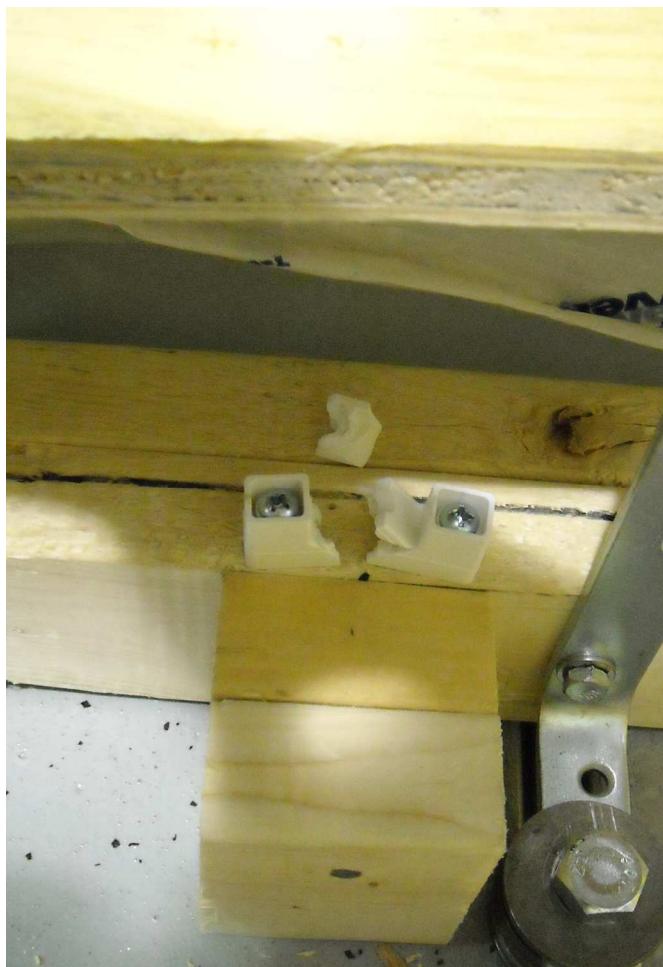
Figure 7: Failure of the clamp base during the uniform load.

During the uniform load test clamps failed at an ultimate load of 79.2 psf. By dividing this load by a factor of safety of 1.5 a suggested design load of 52.8 was obtained. This design load was then compared to the wind pressures in ASCE7. The nearest wind condition found was for a wind speed of 130 MPH at exposure C and a building height of 25 feet. For those conditions, the negative design wind pressure is 52.0 psf and the positive design pressure is 39.5 psf. These design pressures were used for the ASTM E1886/1996 test.

Table 1 shows the result of the uniform load test to which the clamps were subjected. The mode of failure consisted of the base of two of the clamps breaking by the pulling force of the tap bolt. Figure 7 shows a clamp base after failure.

Pressure at Failure (psf)	Failure Mode	Total load at failure (pounds)	Load per clamp (pounds)
79.2	Material failure of clamp base	1425	356
